POST FLOOD PAMPA RIVER MORPHOLOGY AND THE GROUNDWATER SCENARIO OF THE SELECTED WATERSHEDS

Kerala State Remote Sensing And Environment Centre (KSREC)

JUNE 2020

**POST FLOOD PAMPA RIVER MORPHOLOGY AND THE
GROUNDWATER SCENARIO OF THE SELECTED WATERSHEDS
Study Report**

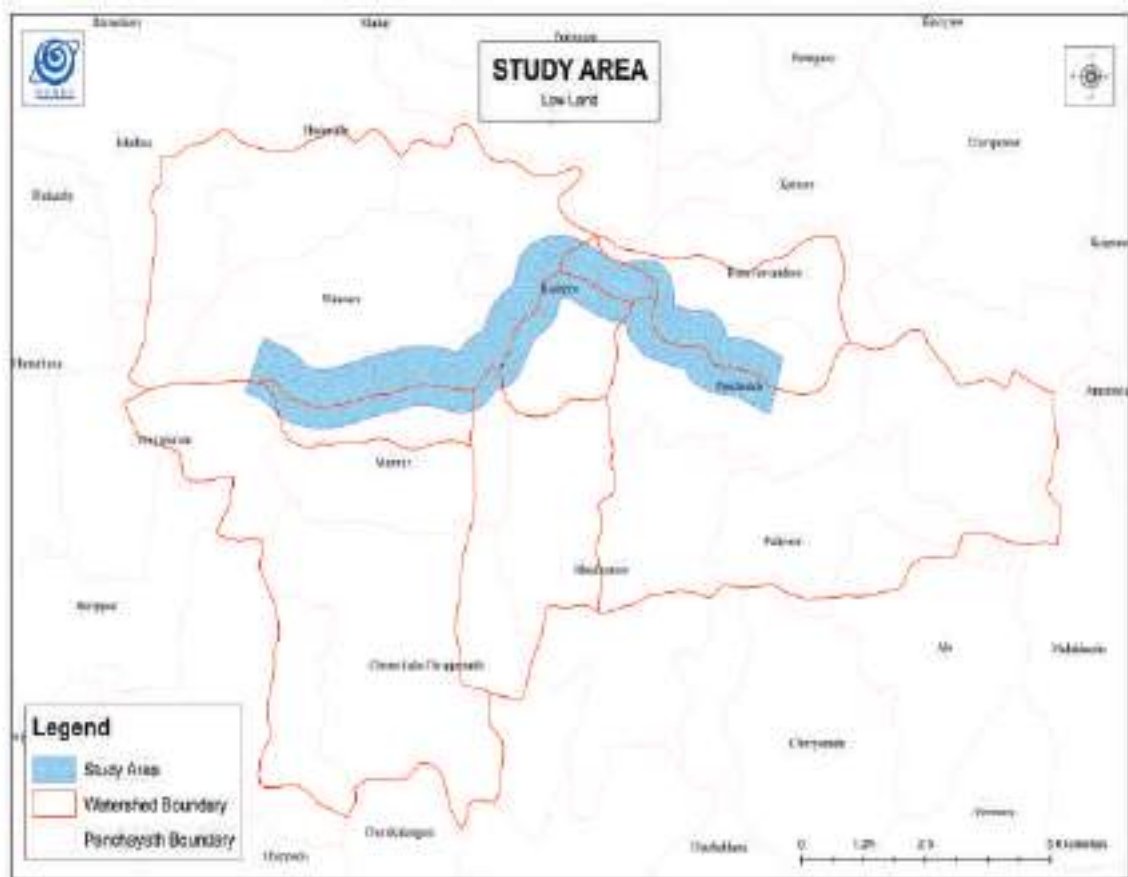
Fig.2.2. Low land study area

The river profiling study is planned in the three stretches and the Soil sample collection and analysis is envisaged from the Micro-watershed area around the three stretches as shown in the figure 2&3. The study area is geographically located in between 9° 19' 00.35" N to 9° 23' 37.22" N and 76° 29' 10.57" E to 76° 50' 51.46" E.

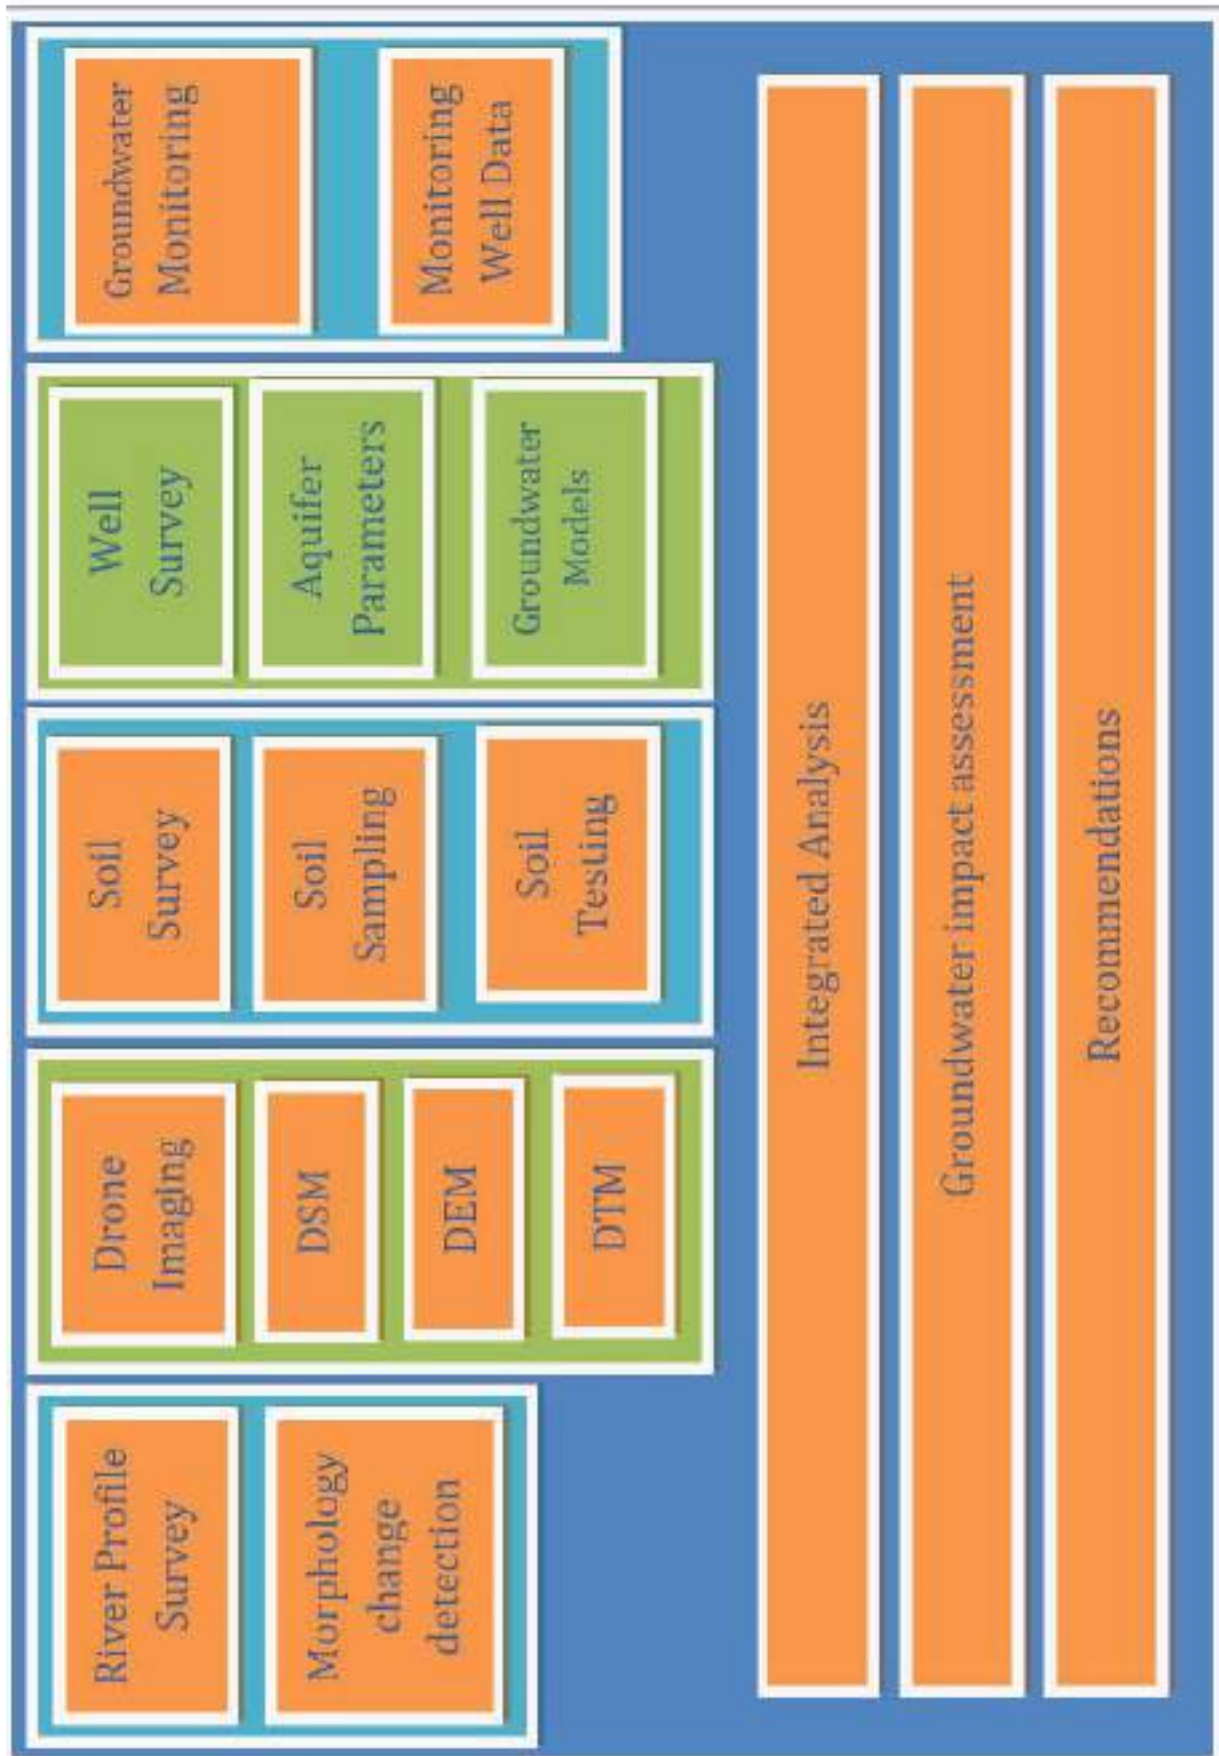
Fig. 2.5. Methodology

The study is intended to characterize the morphological changes that happened to the terrain due to flood and also to identify the impacts the flood created on the soil quality. The groundwater dynamics and the influence of flood on the groundwater dynamics is also aimed at to characterize. A detailed methodology diagram is given below in the figure 2.5.

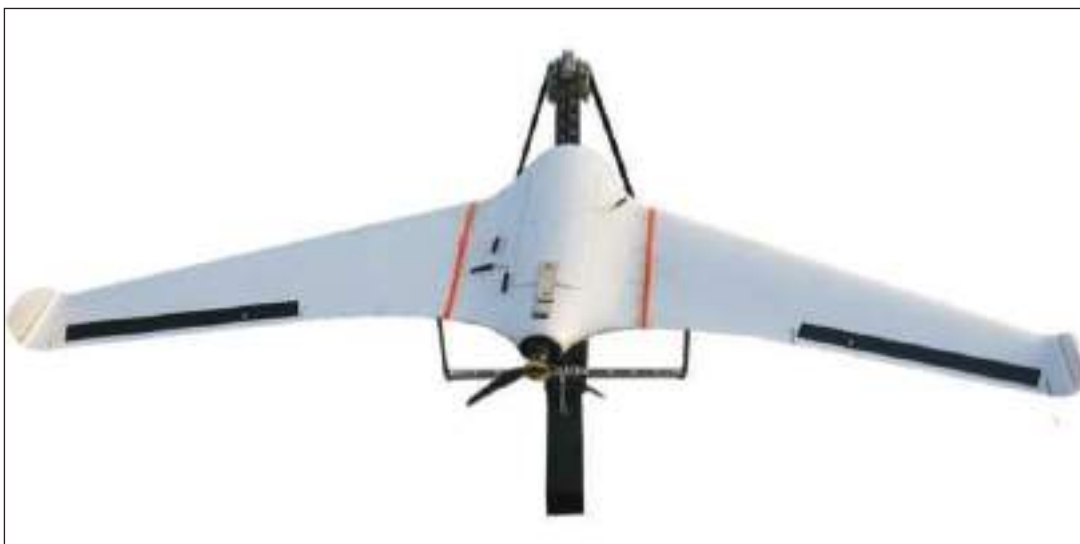
Fig:3.1. Fixed Wing UAV

In this project, Fixed wing UAV (DH-FX Mapper) has been used for acquiring nadir photo (90° photo), which is shown in figure 3.1. It is flown in the direction of east – west and north – south respectively and took 12067 photographs. UAV captured with 70% of side overlap and 75% of forward overlap photographs. These photographs have been used to generate the Orthomosaic image and Digital Surface Model (DSM). Digital Terrain Model (DTM) was extracted from the DSM with the help of Photogrammetry software. The main advantages of this UAV is cost effective, flexible, flying under cloud, long endurance compared to the multi rotor UAV, safe landing mechanism and capture the high-resolution images.

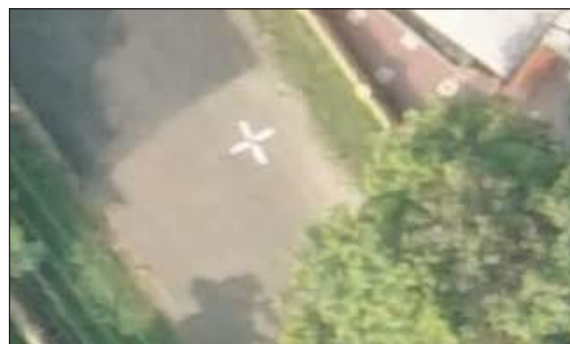
Fig: 3.3.GCP marking

UAV acquires the high resolution aerial images along with GPS location. But the horizontal and vertical positional accuracy of the image position is depending on the pre-surveyed Ground Control Points (GCP). Images position stored using GCS can be used for image processing, but it will give only the relative horizontal and vertical position. To obtain the survey grade positional accuracy of the end product, the pre-defined GCP points were placed on the permanent structure on the ground. These locations were surveyed using Differential Global Positioning System (DGPS) instrument and accurate position details are derived in X, Y and Z format before UAV survey. Sample GCP marking on ground is shown on figure 3.3.

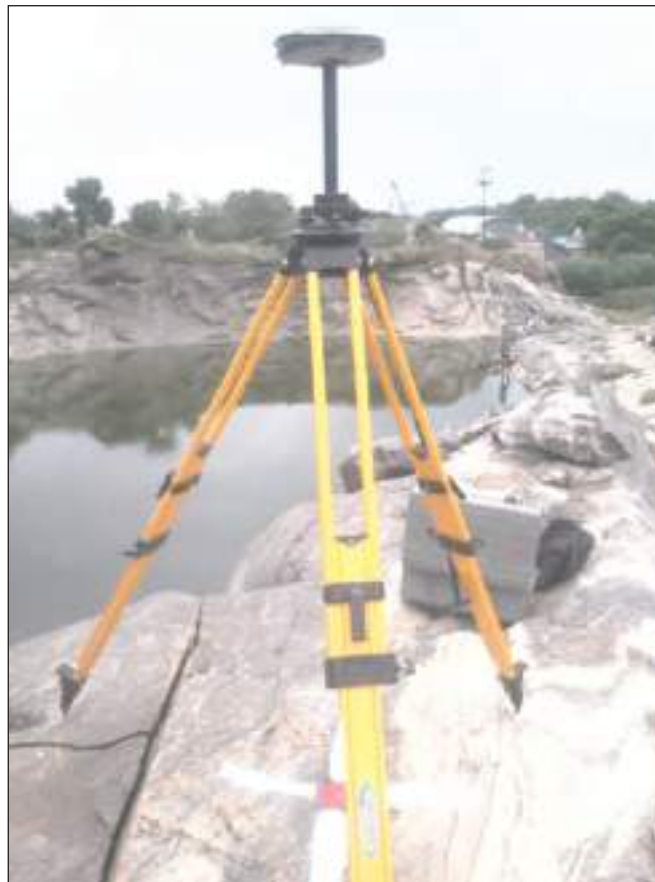
Fig:3.4.DGPS Instrument for GCP Measurement

The Spectra - SP80 DGPS instrument used for GCP observation. It is a new generation GNSS receiver which uses the unique Z-Blade technology to track and process all available GNSS signals, to provide the most reliable measurements and the highest possible accuracies in the challenging environment. The physical structure of the DGPS instrument is shown in figure 3.4.

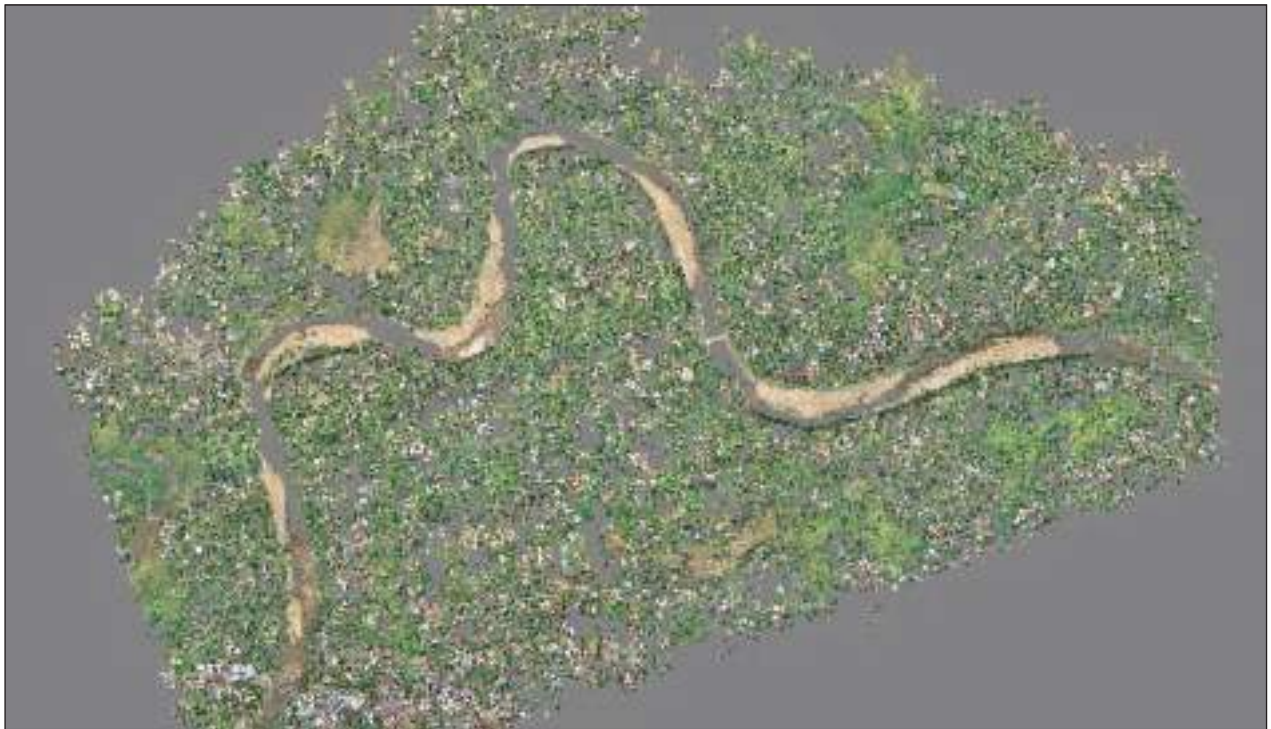
Fig:3.6.Generation of Tie Point

Aligning photo is the initial process to combine the aerial photographs. Pair selection option took the GPS/IMU data to generate the point for combining photographs. This option significantly speedup the processing time. High accuracy setting helps to obtain more accurate camera positions estimates, but it requires huge utilization of full computational power of the system. Lower accuracy setting can be used to get rough camera positions in a shorter period of time. The tie point generated outputs are shown in figure 3.6.

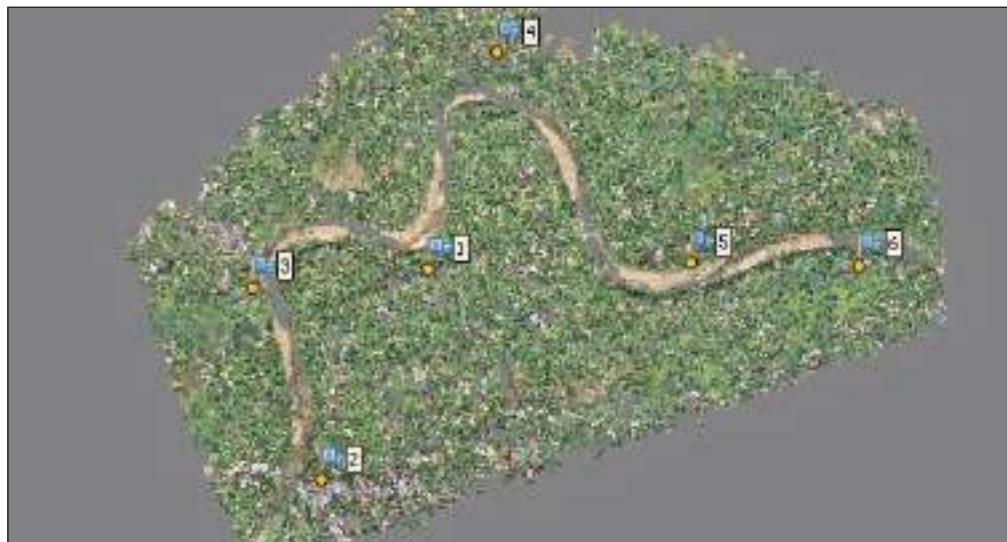
Fig:3.7. GCP Calibration Output

UAV image positions are realigned based on GCP and camera position. Marking the GCP in relevant picture based on the GCP marker and optimized control points update the existing orientation of camera, to compute new orientation which allows the better dense cloud generation. After GCP calibration part of Pamba River is indicated in the figure 3.7.

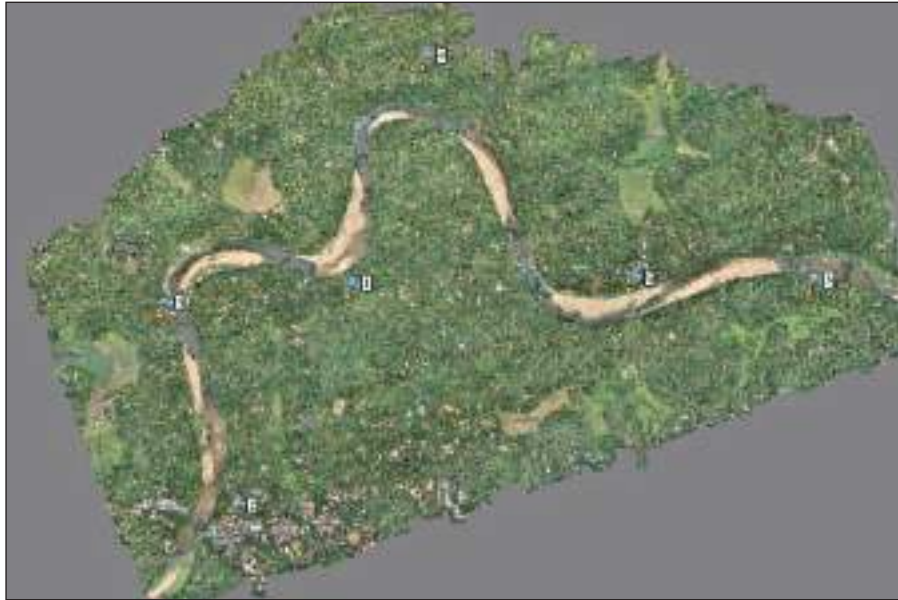
Fig: 3.8. Dense Point Cloud

Build Dense Point Cloud is a computationally intensive operation this will take long time, depending on the quantity and resolution of loaded photo. Structure from Motion (SfM) algorithm is used in this stage; these points can meshed later based on triangulated irregular network connection of generated points. The dense point cloud generated are shown in figure 3.8.

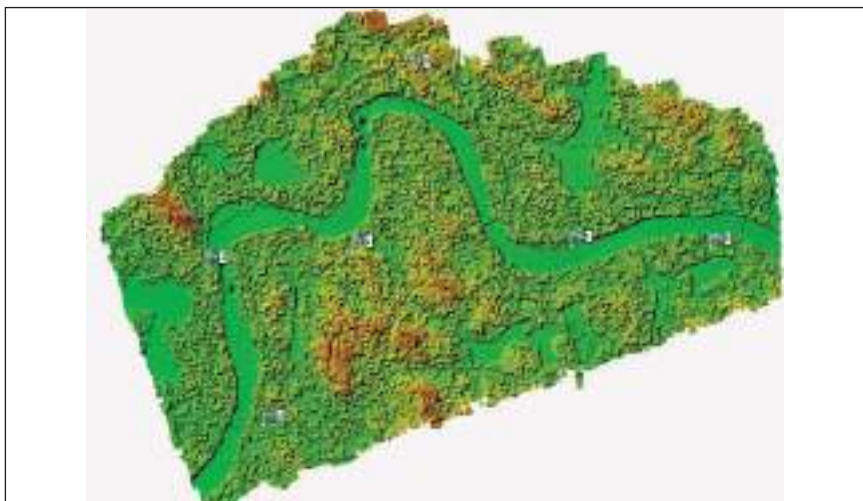
Fig:3.9.Digital Surface Model

A Digital Surface Model (DSM) contains elevations at regularly spaced intervals; however, the elevations represent the first reflected surface detected by Structure from Motion (SfM) algorithm. These first returns may be reflected by bare ground or by surface features such as trees and structures. It is useful for 3D modeling for line of site analysis, telecommunications, urban planning and aviation. The sample DSM generated is shown in figure 3.9.

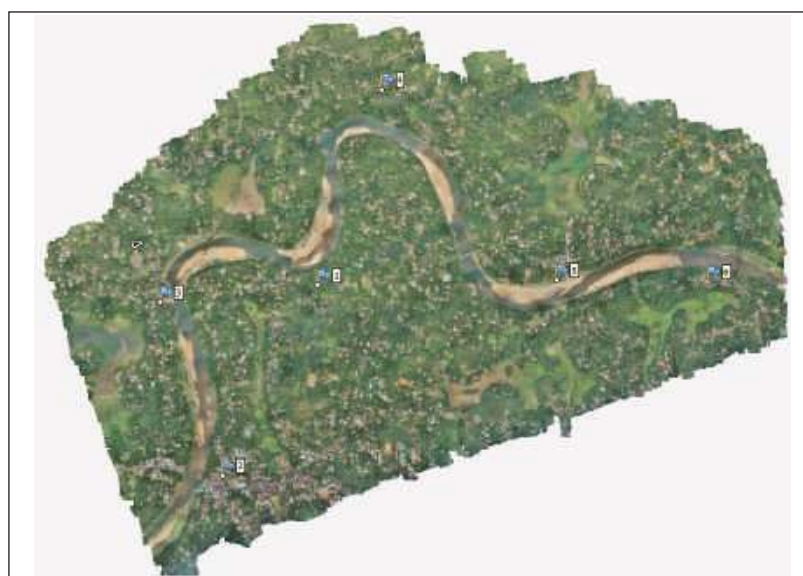
Fig: 3.11.Orthomosaic Image

Orthomosaic image is a detailed, precise photo representation of an area/ object, created out of many photographs that have been combined together and geometrically corrected so that, it is accurate as a map. It has been used to measure true distances, because it is a terrain relief displaced and geometrically corrected one. The sample orthomosaic output is shown in figure 3.11. Orthos are generated at 3 centimeter resolution

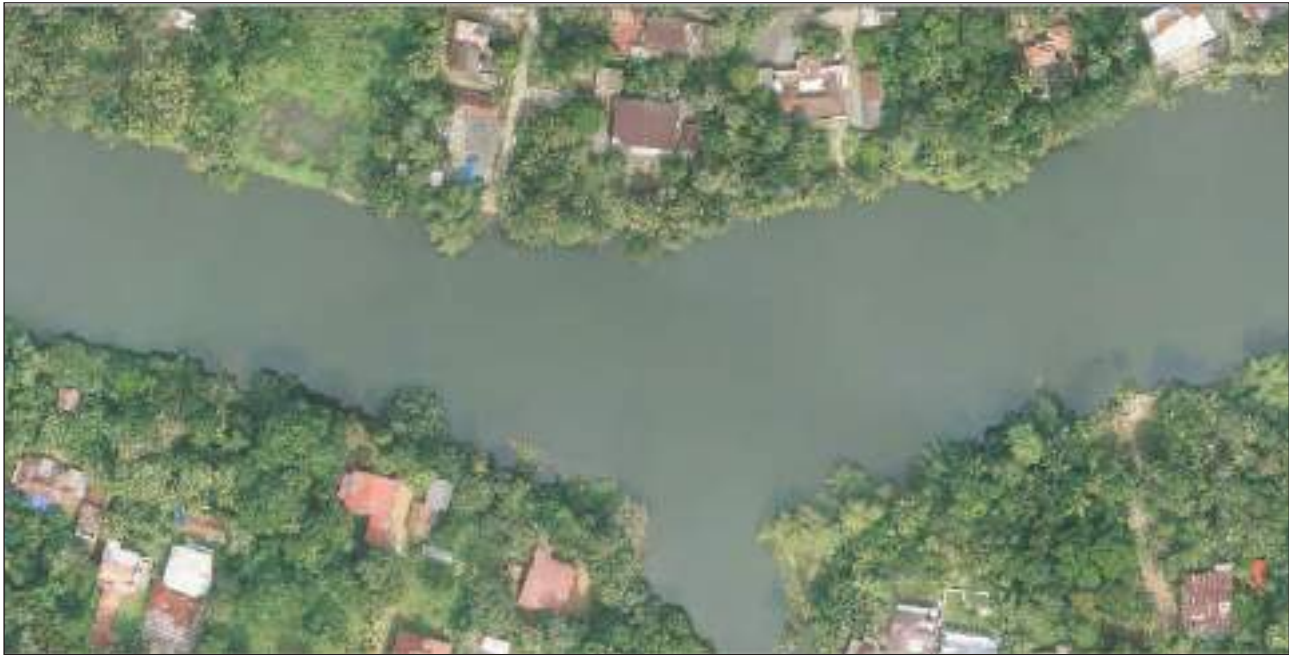
Fig.3.12. Zoom in View of UAV Orthomosaic

viz it can capable to view 3 centimeter level object on ground in 1pixel.The zoom in view of UAV based orthois shown in figure 3.12. The high resolution satellite data view of the zoomed area is shown in figure 3.13.

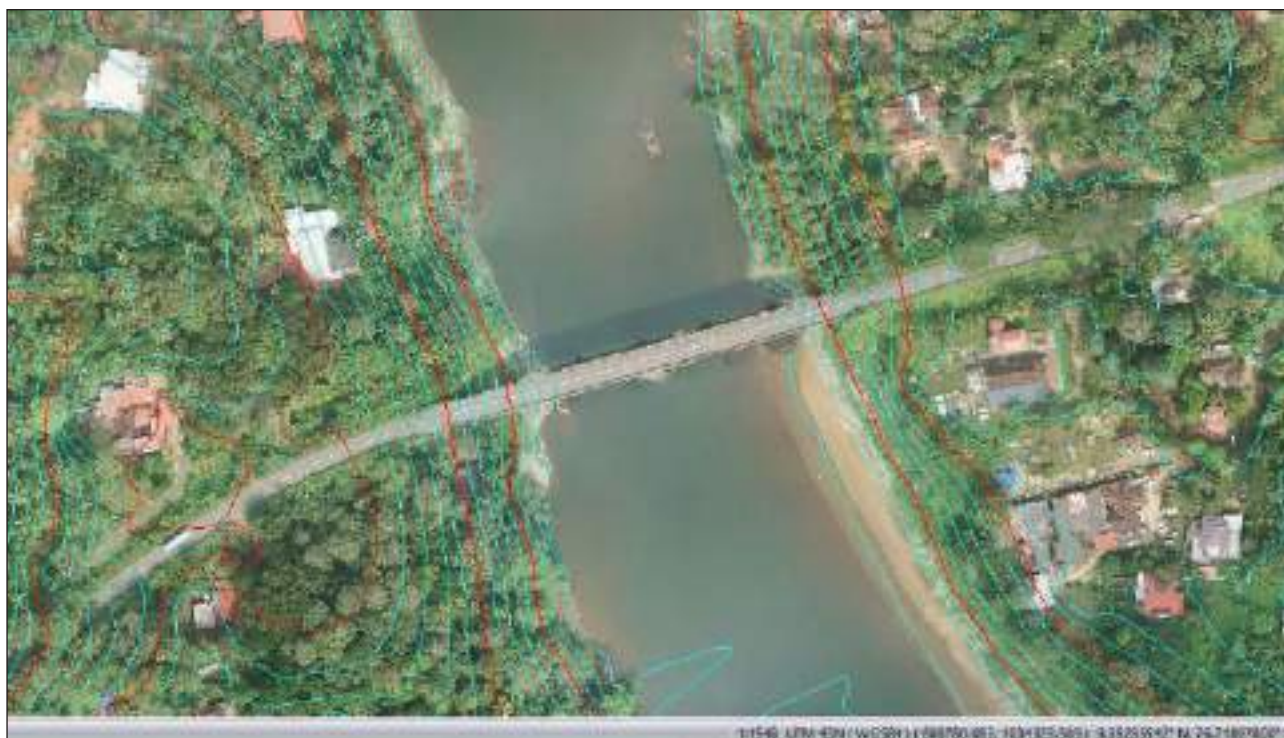
Fig:3.14.One meter contour of Midland

Contour represents 2D line connecting equal altitude (elevation) reference to Mean Sea Level (MSL). It is helpful to visualize the terrain elevation from printed maps. These contour lines are used to calculate terrain geometrics such as slope, water flow, cut and fill locations of undulations or hazards in the existing surface. Contours are generated at 1 meter interval and every fifth contour is considered as major contour. Contours were generated free from self-intersection and depression polygon. Contours were smoothed for better visualization and appearance. The sample contours overlaid on orthophoto of Midland is shown in figure 3.14.

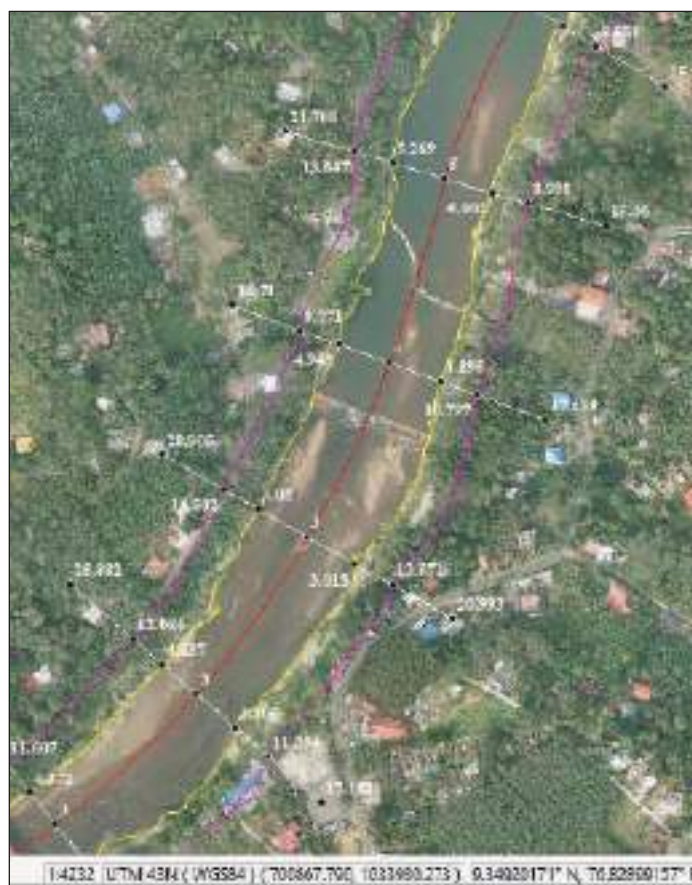
Fig: 3.15. River Profile Cross Section Overlaid on Orthomosaic of High land

River profile provides cross-section of a river's channel and valley at specific user defined interval. River Profile Cross Section consists of River center line, River edge, Buffer for River edge and cross section for river center line at specific interval (150 meter). In this project, all the above mentioned features are digitized with the help of Ortho and DTM. The digitized features are dropped on DTM and converted to 3D shape files. This shape files are used for water flow simulation, erosion identification, identify the potential sand deposit area, water flow change deduction, flood prone area identification etc. River cross sections are generated as DWG and ESRI shape file format for easy interoperability. The sample river cross section file of portion of high land is shown in figure 3.15.

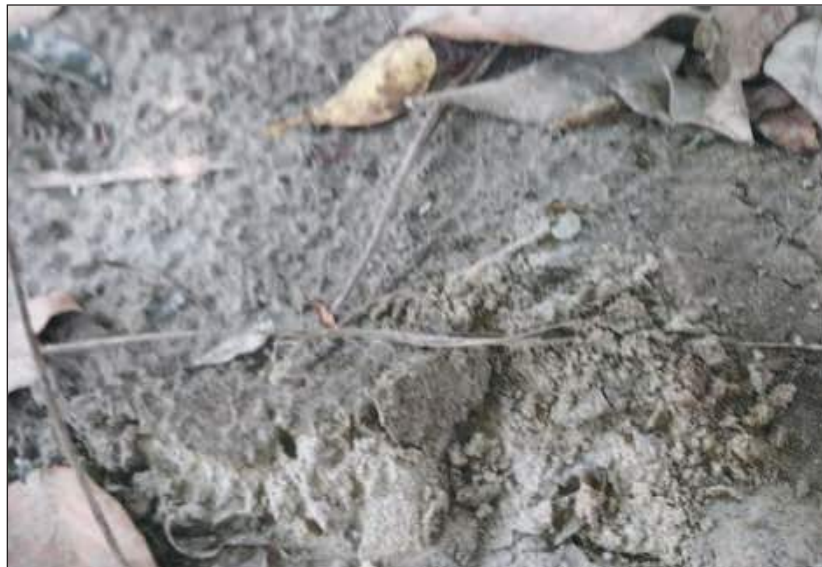
Large quantity of sand, silt and clay were seen deposited on the surface soils of the affected panchayaths (Fig.4.1. to 4.3). The thickness of deposition varied from 2cm to 10cm. Soil crusting was also reported from these depositional areas of Thiruvalla Taluk viz: Nedumpuram, Peringara, Kadapra, Niranam and Kavumbhagam. These are low land valley areas under upper Kuttanad with wide stretch of punchapaddy fields, except Kavumbhagam, which is a low land valley. Panchayath wise details given by Soil Survey and Soil Conservation department in their report are as follows.

Fig:4.1. Sandy loam deposited in the area- with low organic matter and high pH.3.7 (Soil Survey and Conservation, 2018)

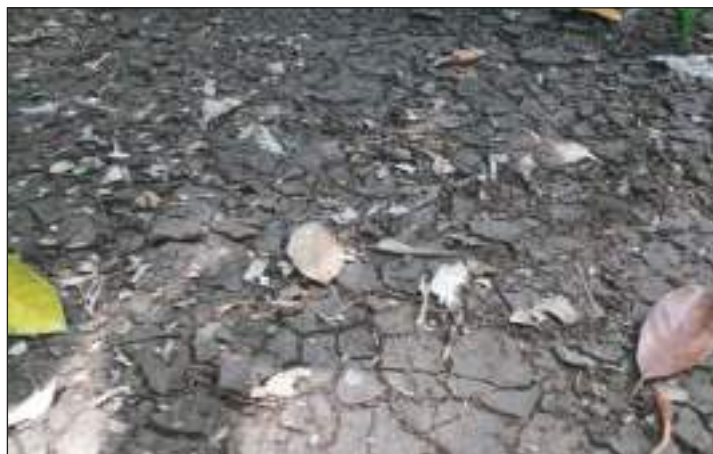
Fig:4.2. Deposited silt (Soil Survey and Conservation, 2018)

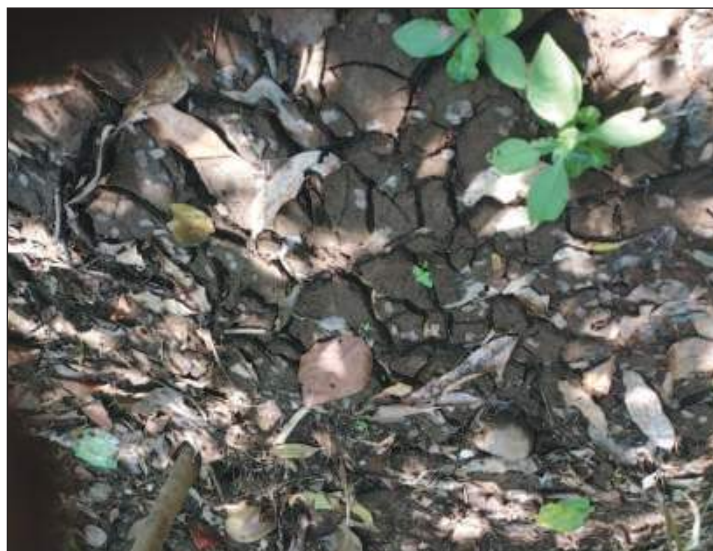
Fig:4.3. Clay deposits (Soil Survey and Conservation, 2018)
